## Report of Findings

### STRUCTURAL EVALUATION

Claim No: 1002259499

Re: STRUCTURAL EVALUATION-314 E. 8TH ST.-CUSHING OK

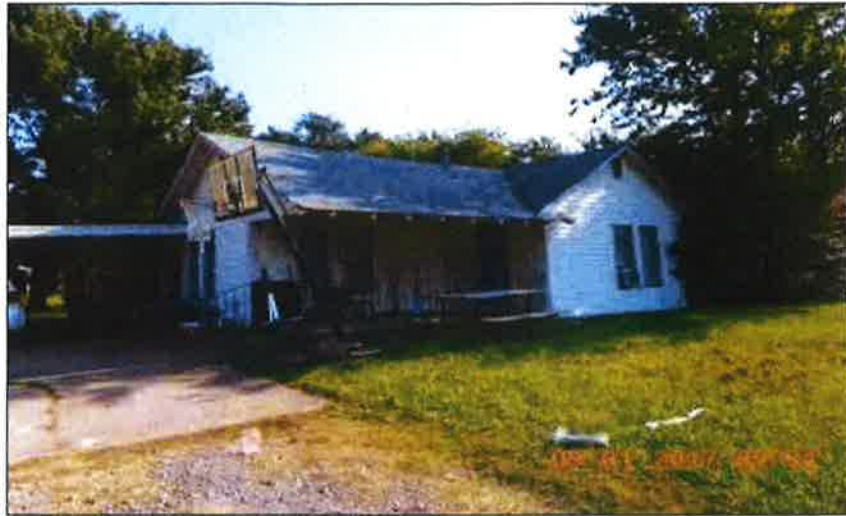
**Photograph 1**  
South side.

The residential property was a one-story, wood-framed dwelling covered with vinyl siding on the exterior. The foundation was a combination shallow foundation perimeter walls of an unknown material with portions of concrete slab foundation added later. The interior wall finishes were a combination of lath and plaster and drywall with paint. The ceiling was furring strips with acoustical ceiling tiles. The flooring was a combination of carpet and vinyl flooring. The roof covering was asphalt shingles. For the purposes of this report, the side of the residence with the front entrance door faces south, refer to **(Photographs 1 through 5)**.

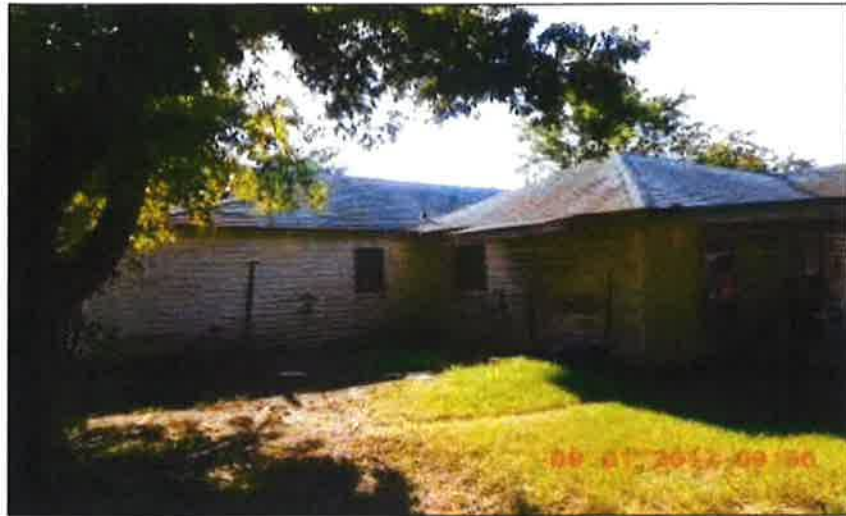
**Photograph 3**

Rear east side.

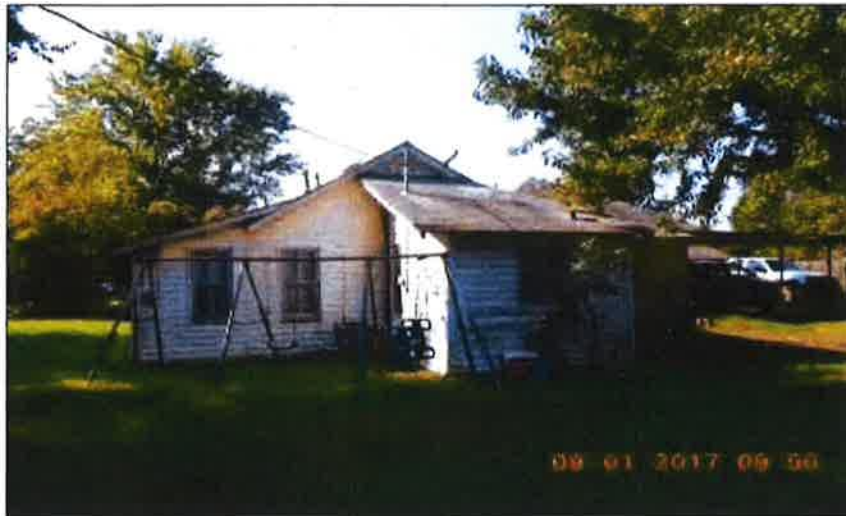
**Photograph 4**

North side.

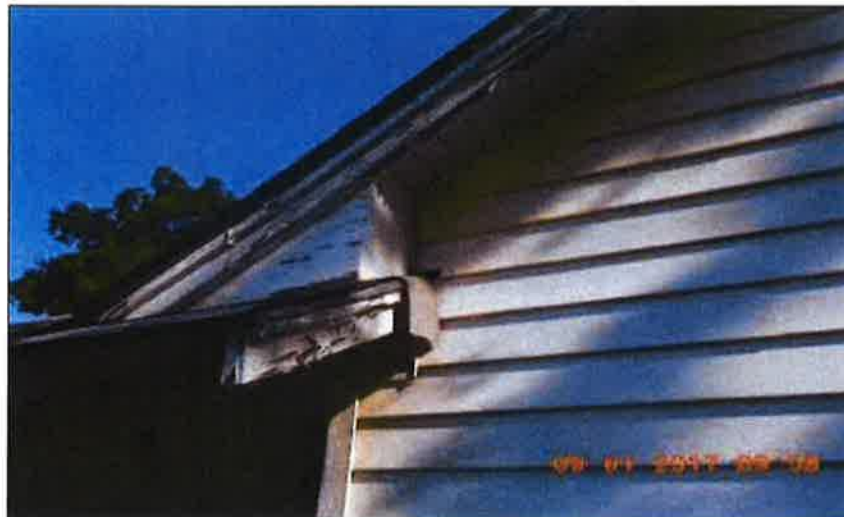
**Photograph 6**  
Roof connection.

- The roof rafter connections to the wall framing were observed to be intact and without separation. Roof framing locations that did have cracks or separations were observed to have dust and cobwebs within the separations (**Photographs 6 through 8**).

The uneven floor was determined to be caused by differential foundation movement. The crack along the wall and leaning wall were determined to be caused by a poorly constructed floor extension consisting of an added footing adjacent to an interior slab. Other interior cracks showed signs of age and contained no stretched or cracked paint. The residence was out of plumb in several locations with the cause being differential foundation movement. Horizontal cracks were observed in the driveway slab and the front porch. These cracks showed signs of age and were consistent with shrinkage cracks and differential foundation movement cracks. Furthermore, cobwebs and insect nests were observed in several of the separations indicating they were not recently formed.

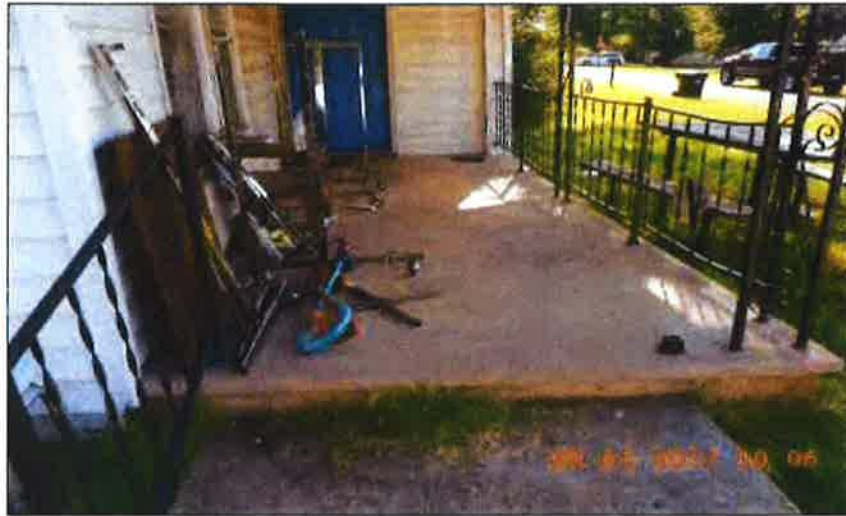
**Photograph 9**  
Front porch.

- The slab supporting the front porch contained cracks. The stem wall was covered by the vinyl siding (**Photographs 9 through 11**).
- Cracks existed in the driveway slab under the carport. The cracks contained dust and showed wear over time along the edges of the cracks. (**Photographs 12 through 14**).

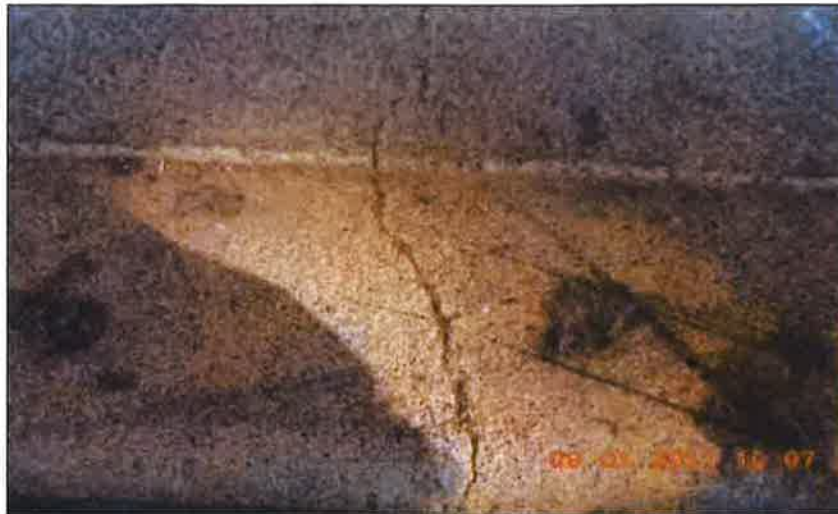
**Photograph 11**

Front porch crack.

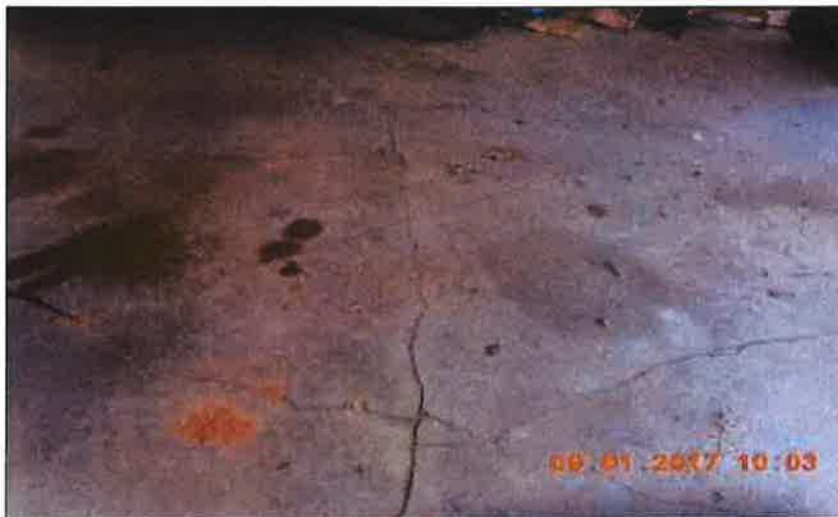
**Photograph 12**

The origin of the damage observed to the floor, ceiling tiles, and driveway slab under the carport was from differential foundation movement related to volumetric soil changes from soil moisture variations over time. This is shown by the floor elevations that demonstrate variation in ground movement over an extended period of time. Poor construction techniques found at the foundation contributed.

Driveway crack.

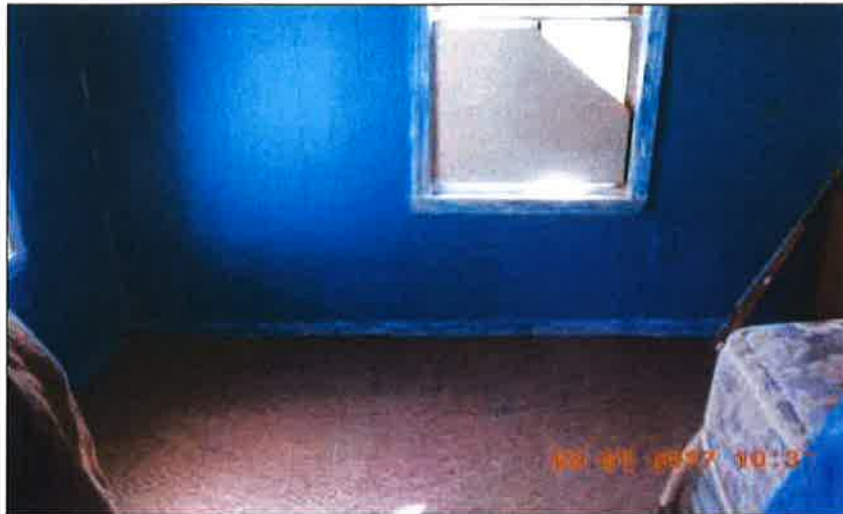
**Photograph 15**  
Son's room.

- The floor inside the residence had several areas of bowing (**Drawing Attachment B**).
- The carpet was pulled back in the son's bedroom, and the concrete under the carpet was examined. The concrete had an area where it had been patched. It was cracked and broken. Examining below the broken pieces of concrete, it was determined that the room was extended at some point and a new strip footing had been added, and there was plywood incorporated in the footing. (**Photographs 15 through 19**).

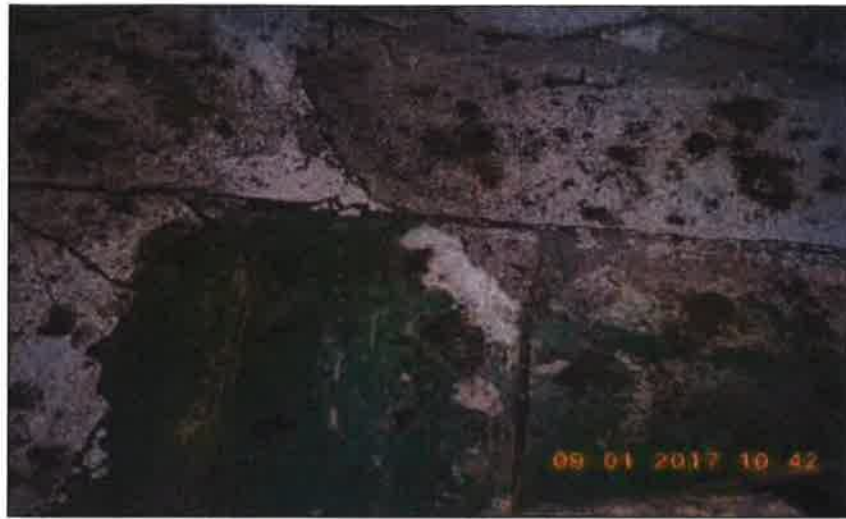
**Photograph 17**

Son's room floor under the carpet.

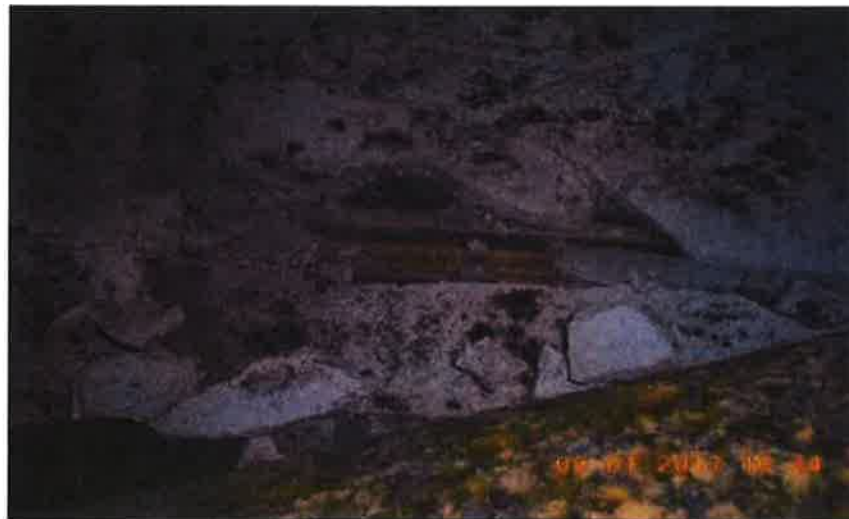
**Photograph 18**

Son's room floor under the carpet.

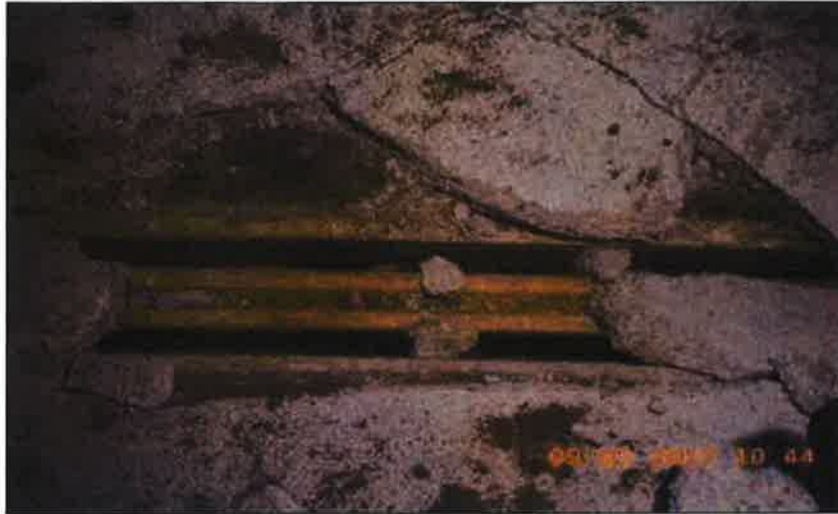
**Photograph 19**

Son's room floor under the carpet.

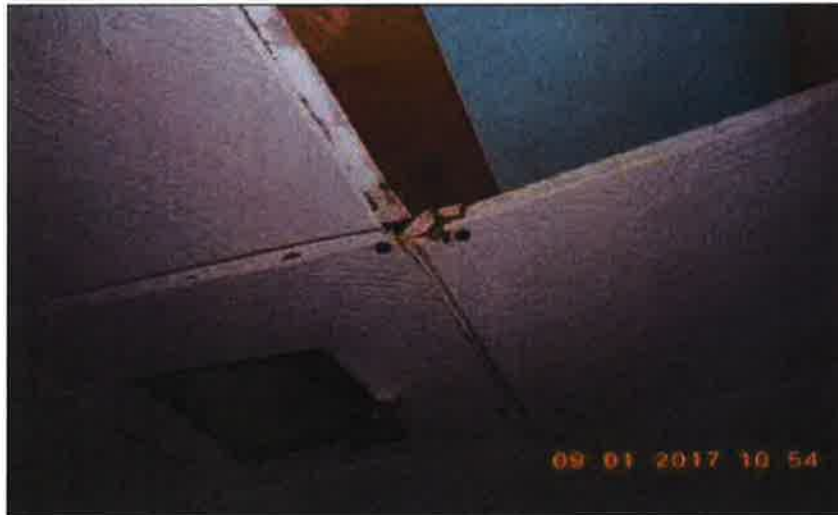
**Photograph 20**

- It was observed that the ceiling in the bathroom and son's bedroom had ceiling tiles that were missing. Repairs of these tiles were observed to be aged (**Photograph 20**).
- Several cracks were noticed throughout the residence. All were observed to have paint inside the cracks (**Photographs 21 through 23**).

Ceiling tiles.

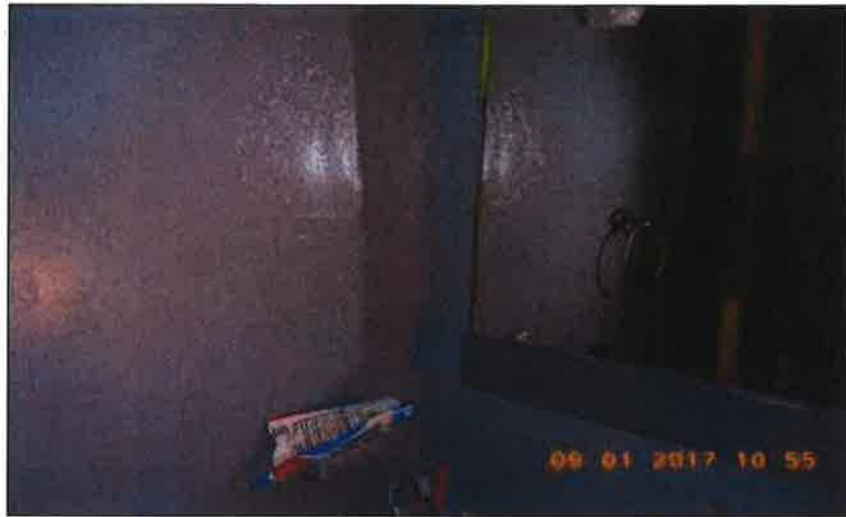
**Photograph 21**

Bathroom cracks.

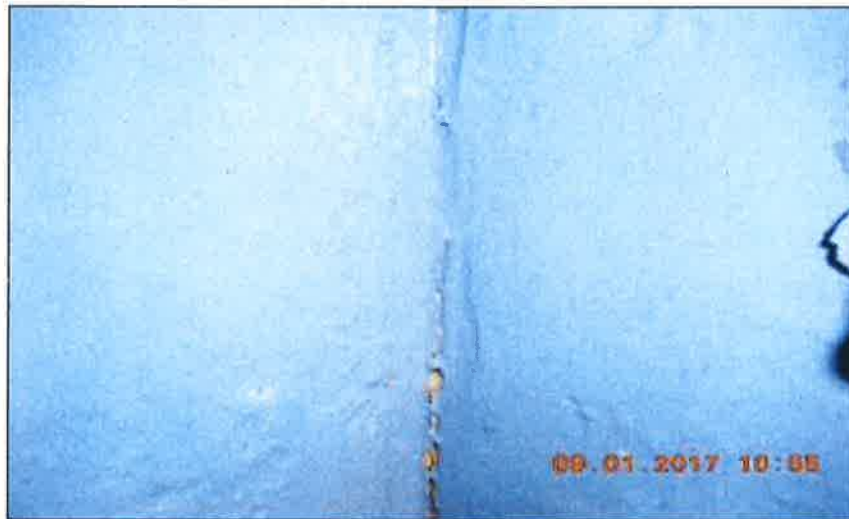
**Photograph 22**

Bathroom cracks.
